HISTORIC STRUCTURE REPORT
HOME OF FRANKLIN D. ROOSEVELT

Architectural Data Section

Roosevelt-Vanderbilt Sites
Hyde Park New York

Peggy A. Albee

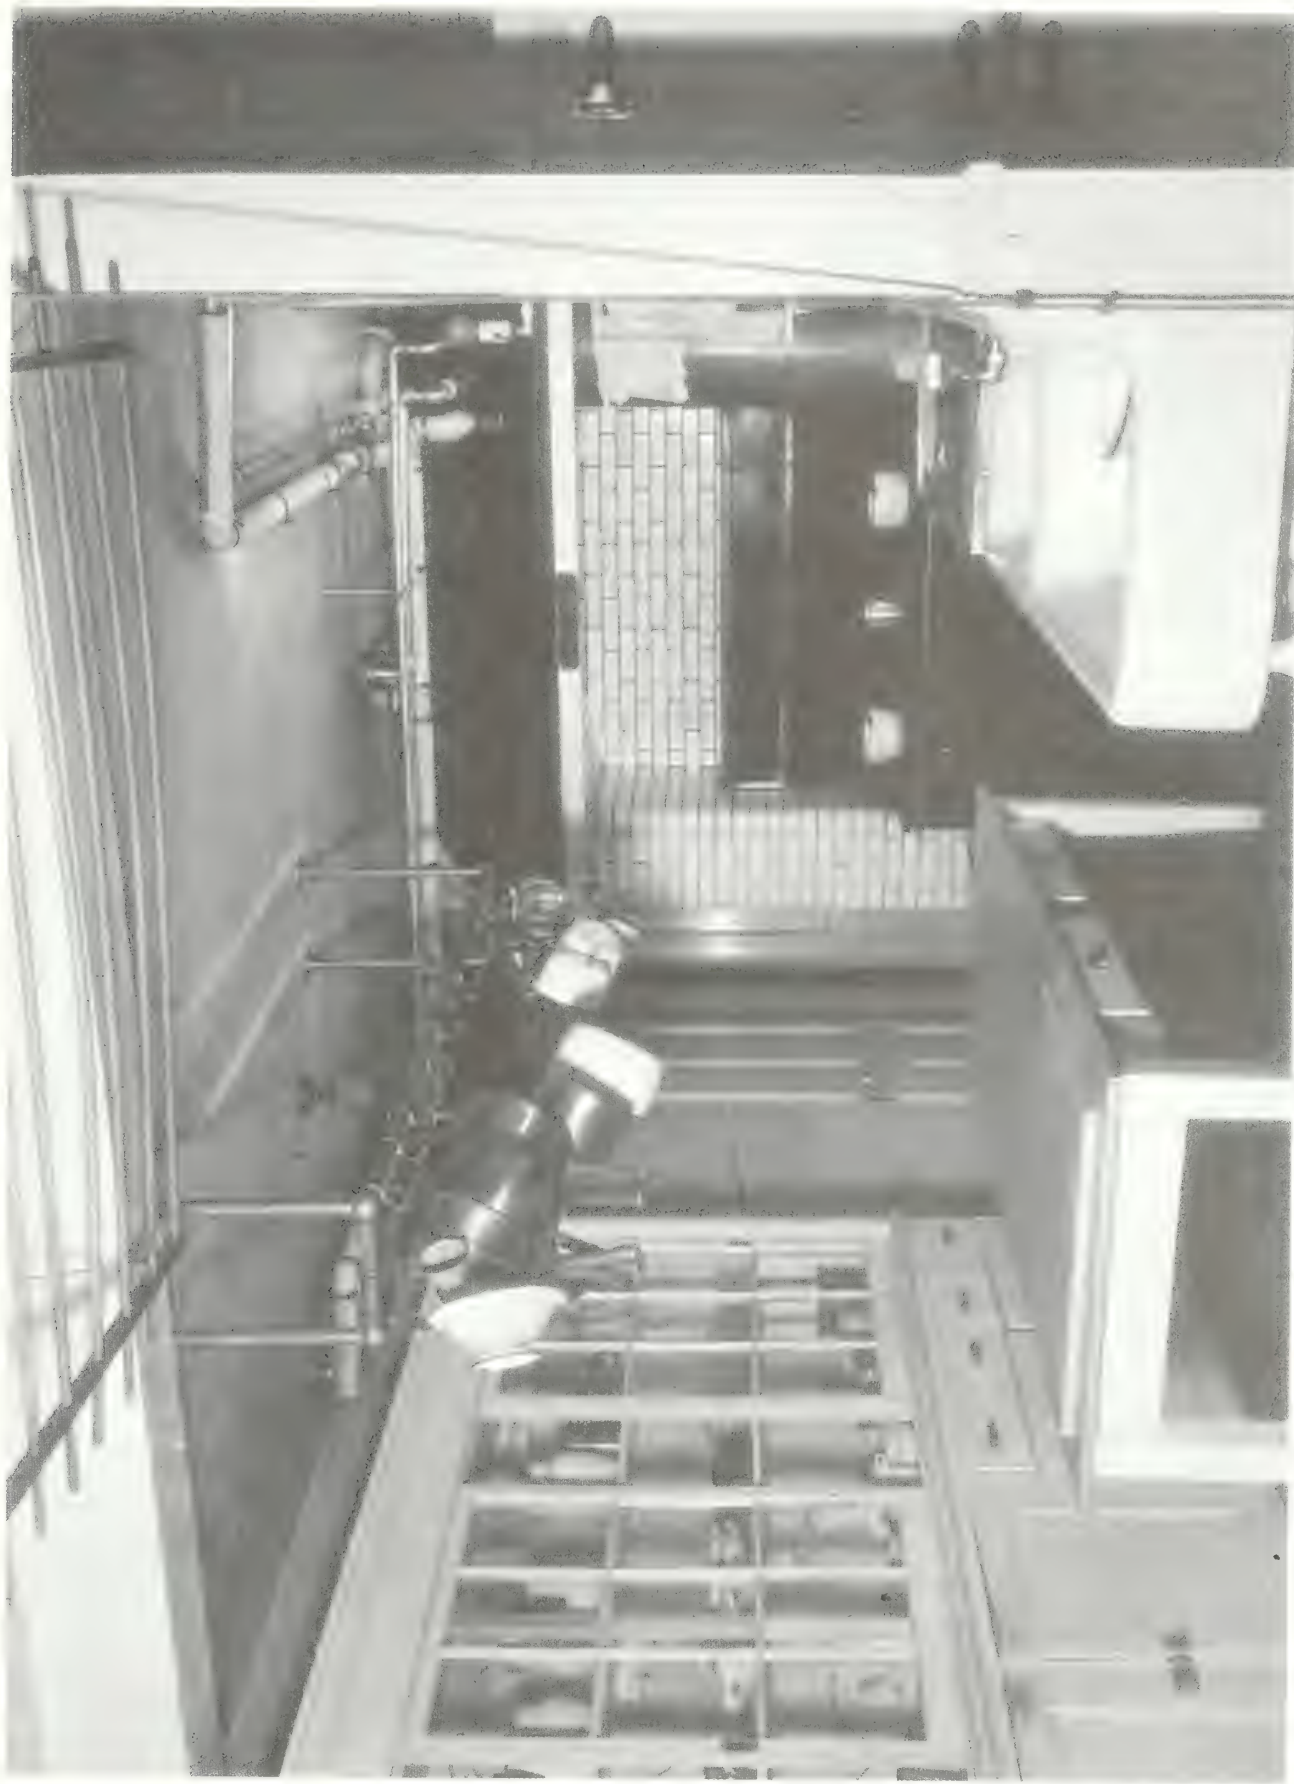
Figure 63. Home of FDR: Kitchen, looking southeast, 1941.

This room (fig. 63) sits partly within the original (ca.-1800) kitchen wing and partly within the ca.-1850 east-west extension to that wing. It was created in its present L-shaped form in 1915, with a large main section and a shallow northwest ell. Primary features include the cook stove on the south wall and the Cold Room off the northeast corner.

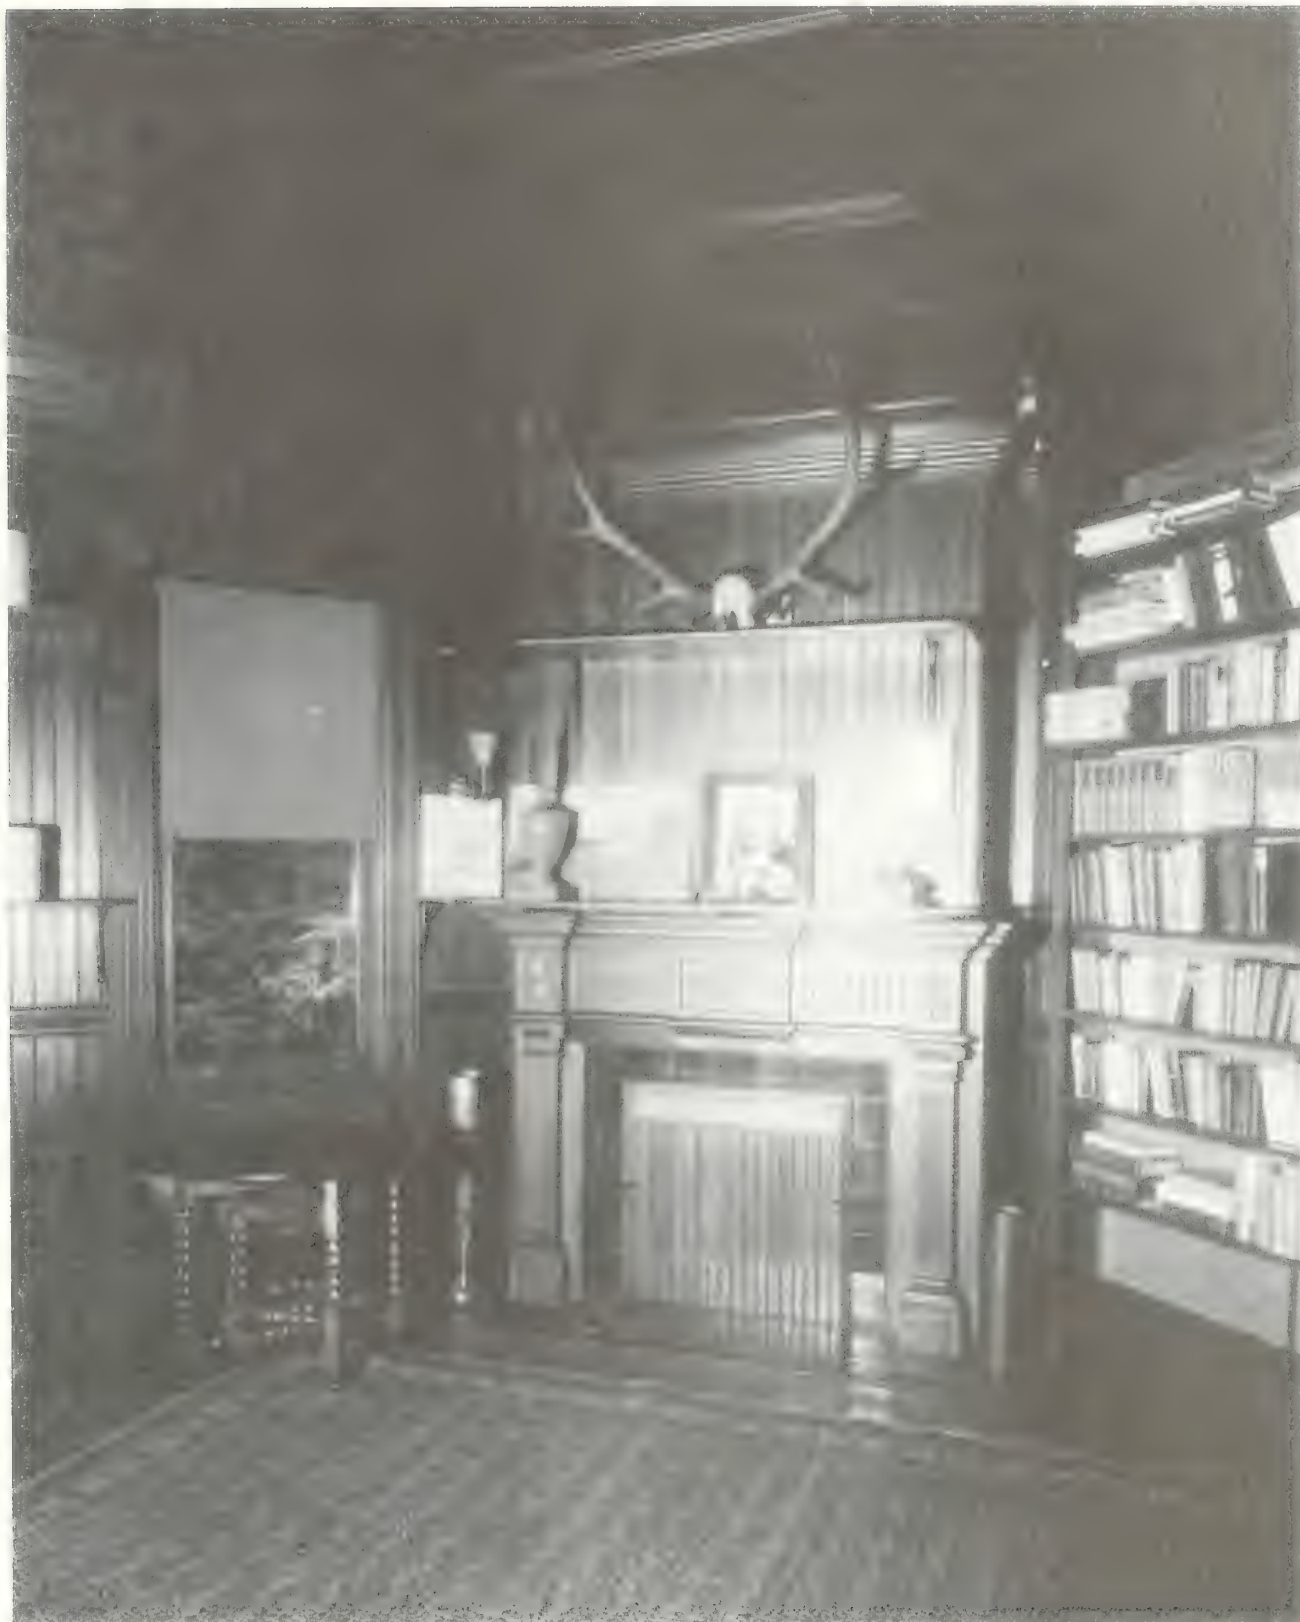
Figure 65. Home of FDR: Smoking Room, looking north, 1941.

This room (fig. 65), situated in the northwest octagon addition, was built in 1887. Its cornice, ceiling moldings, wall elevations, and mantel are depicted in Appendix B, sheet 33.

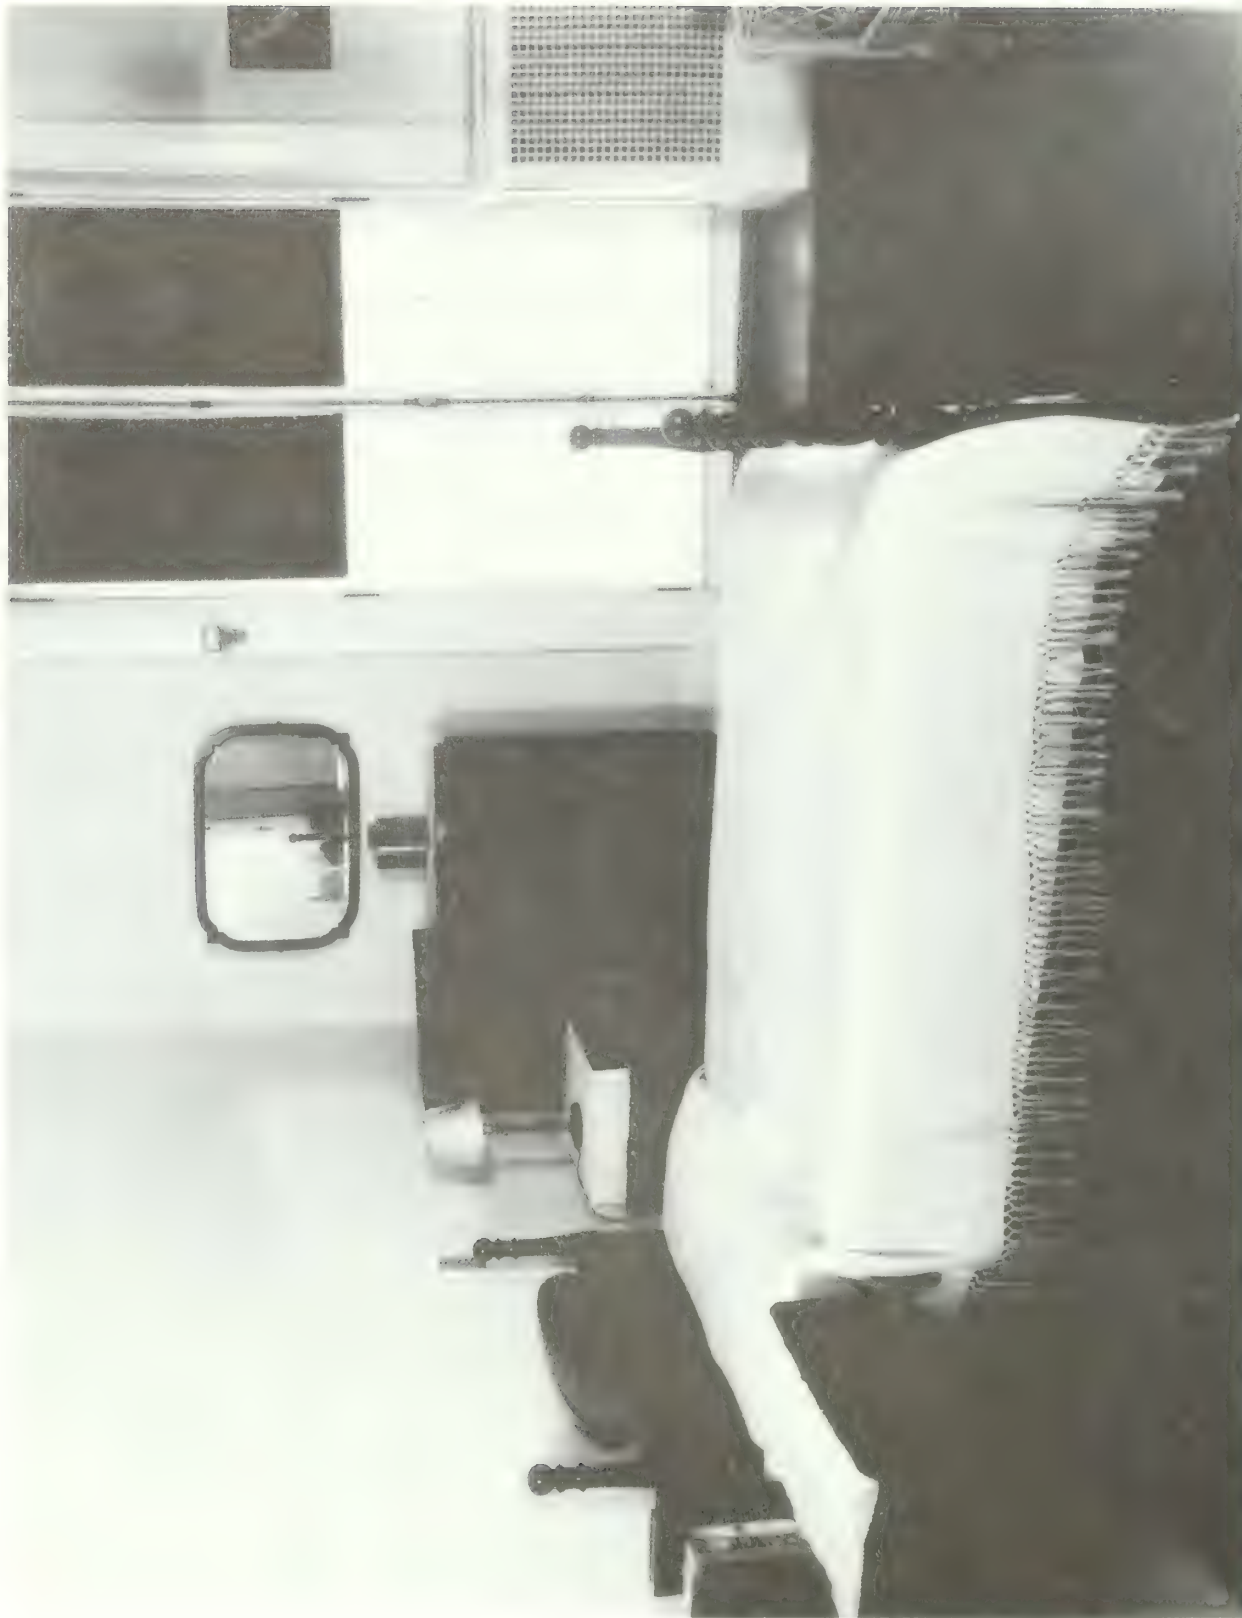
Figure 66. Home of FDR: Eleanor's Bedroom, looking south, 1946.

This room (fig. 66) is also part of the 1915 south wing. Its northwest and northeast corners are partitioned off for closets; a narrow passage between them leads to the north-wall doorway to the main hall.

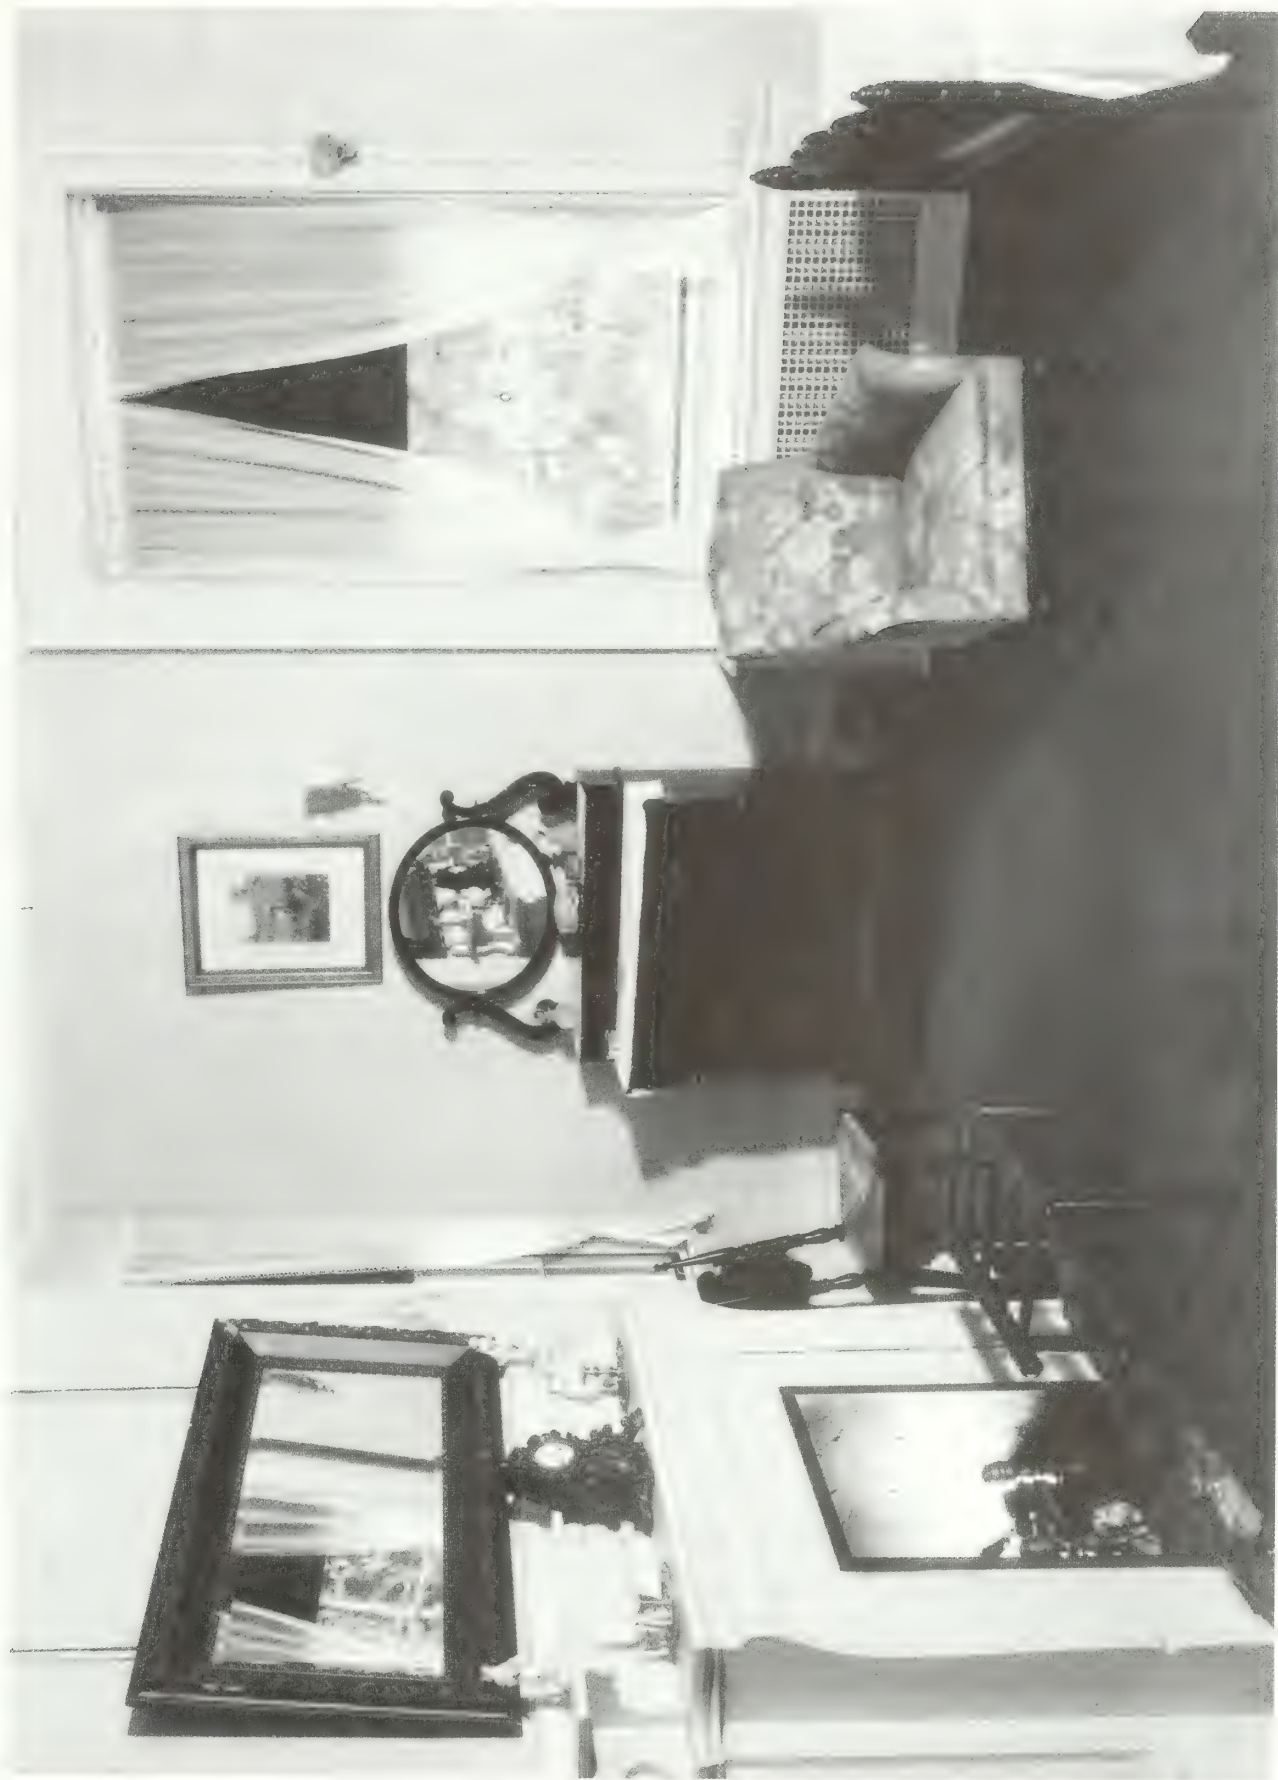
Figure 68. Home of FDR: Birth Room, looking northeast, 1941.

This room (fig. 68) was part of the ca.-1850 south tower. It was the master bedroom for James and Sara Roosevelt, and Franklin was born here. It had a dressing room along its west wall and a fireplace on its north wall. During the 1915 remodeling, the dressing room was taken for a hallway; a new bedroom was created for Sara in the south wing; and Room 206 became the new Morning Room. The room is today referred to as the Birth Room. A closet is located at the south end of the west wall.

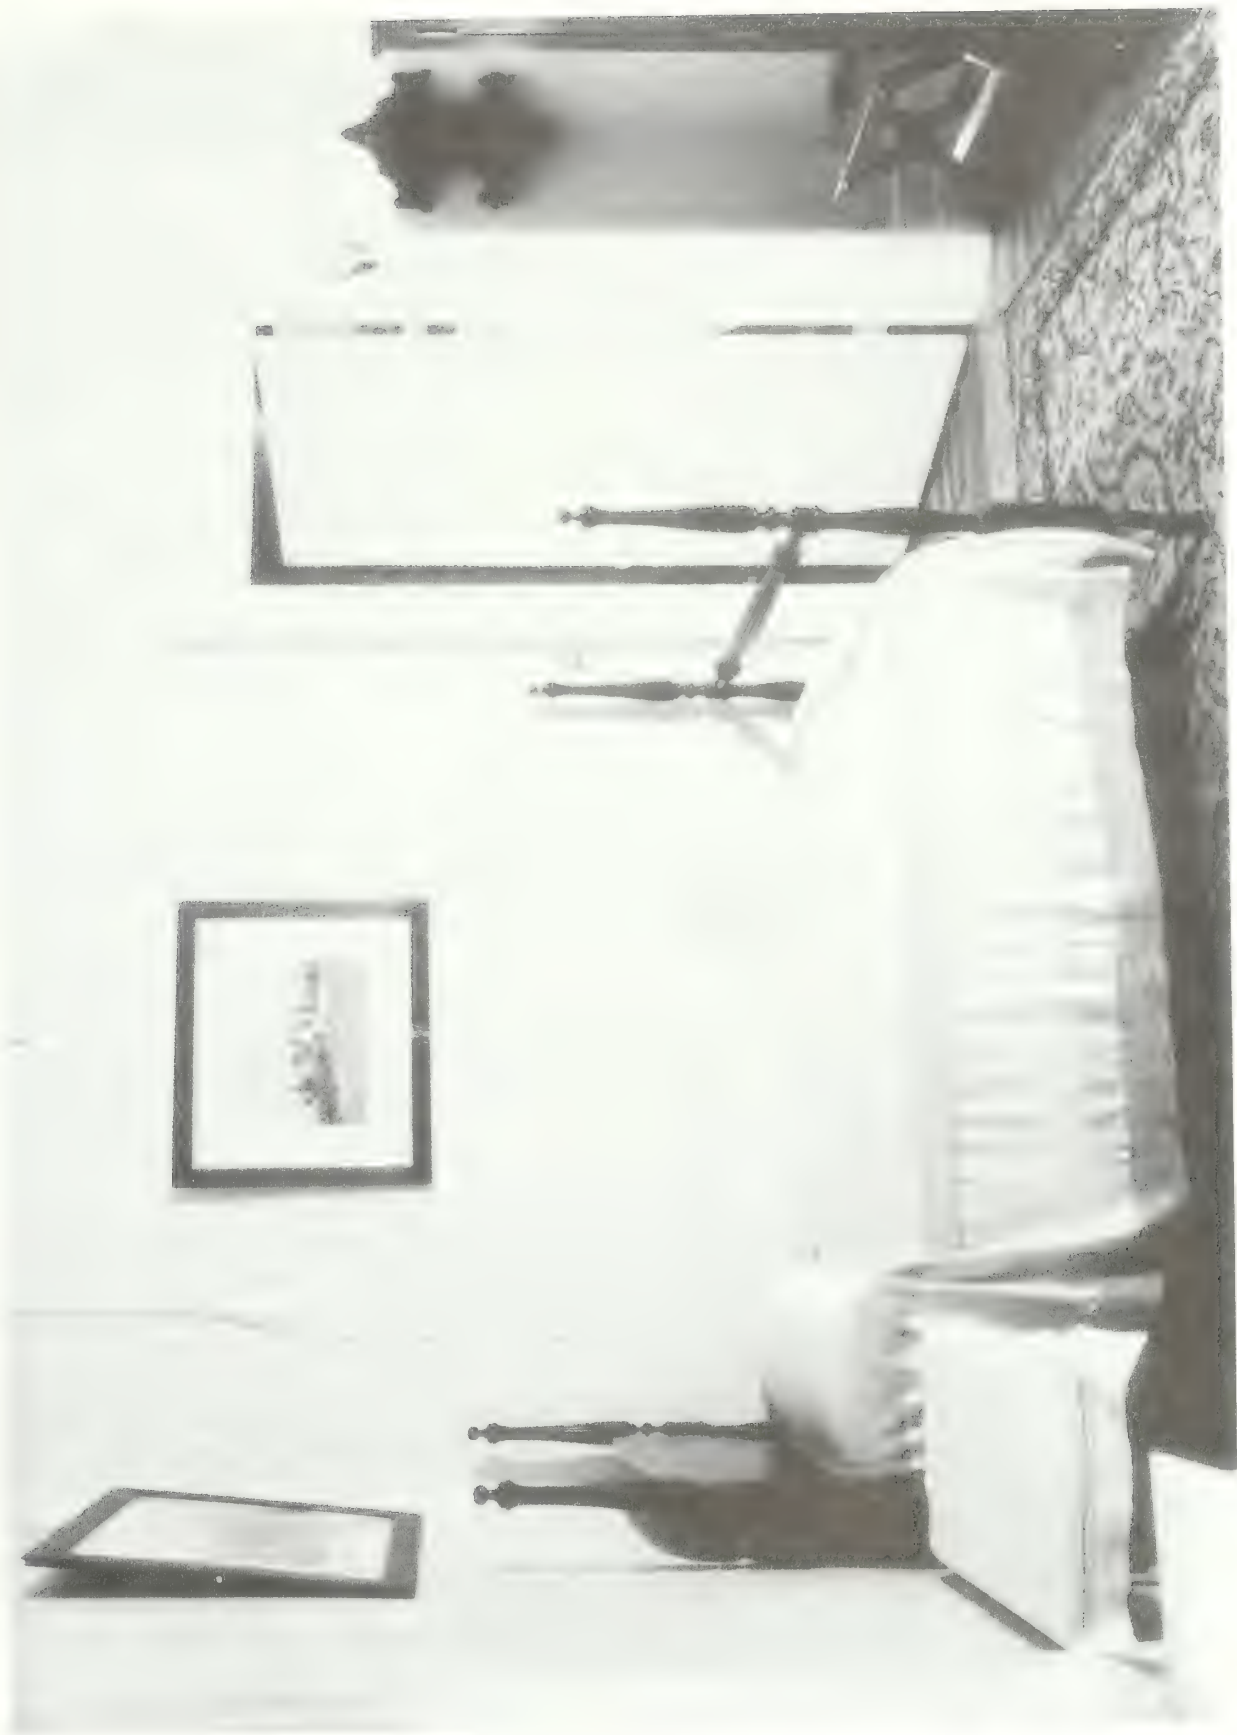
Figure 69. Home of FDR: Blue Room, looking south, 1941.

This southeast bedroom (fig. 69) is part of the original ca.-1800 house. When James and Sara Roosevelt were using the ca.-1850 south tower room as their bedroom, this room served as the Morning Room. After the construction of the south wing in 1915, Sara moved her bedroom there, and began using the south tower room as the Morning Room.

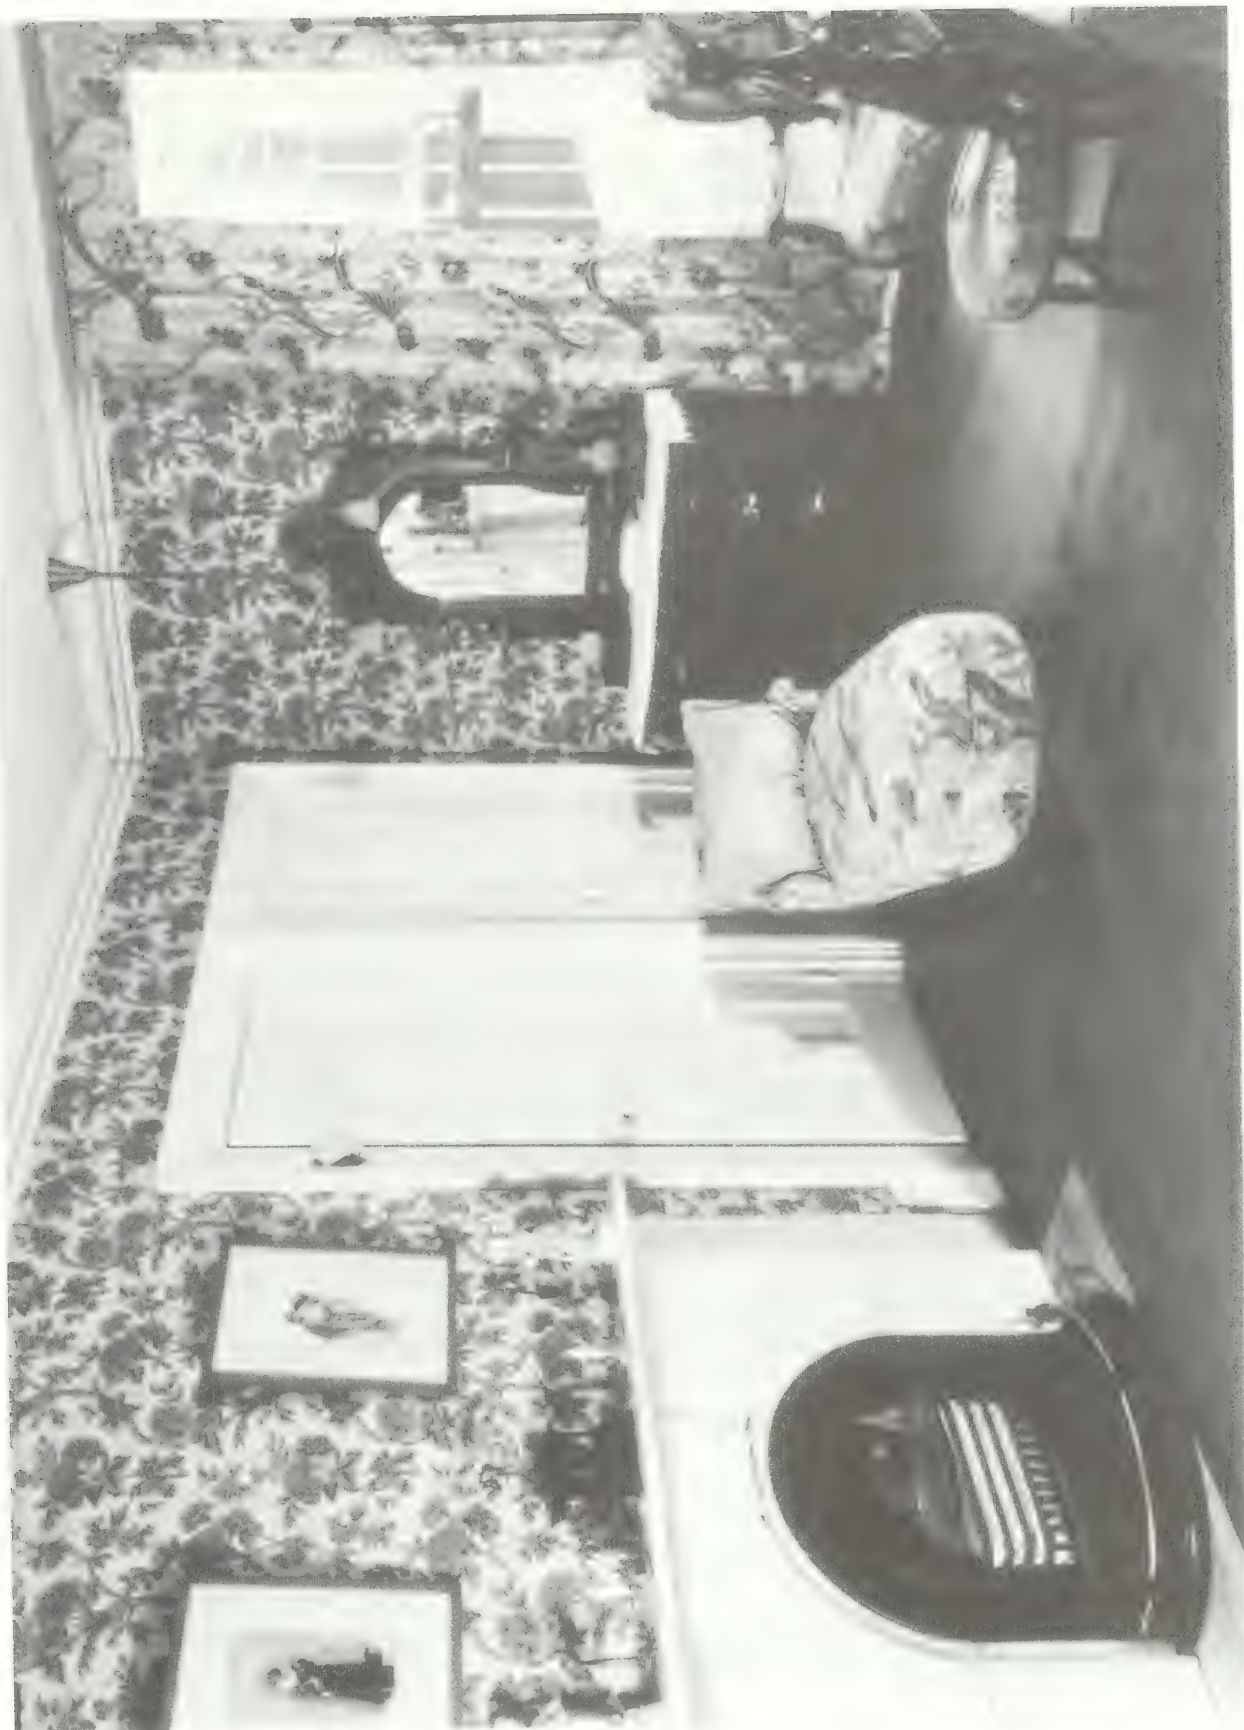
Figure 70. Home of FDR: Chintz Room, looking southeast, 1941.

This southwest bedroom (fig. 70) is part of the original ca.-1800 house. It has a fireplace and two closets on its east wall. Its baseboard and south window are depicted in Appendix B, sheet 32.

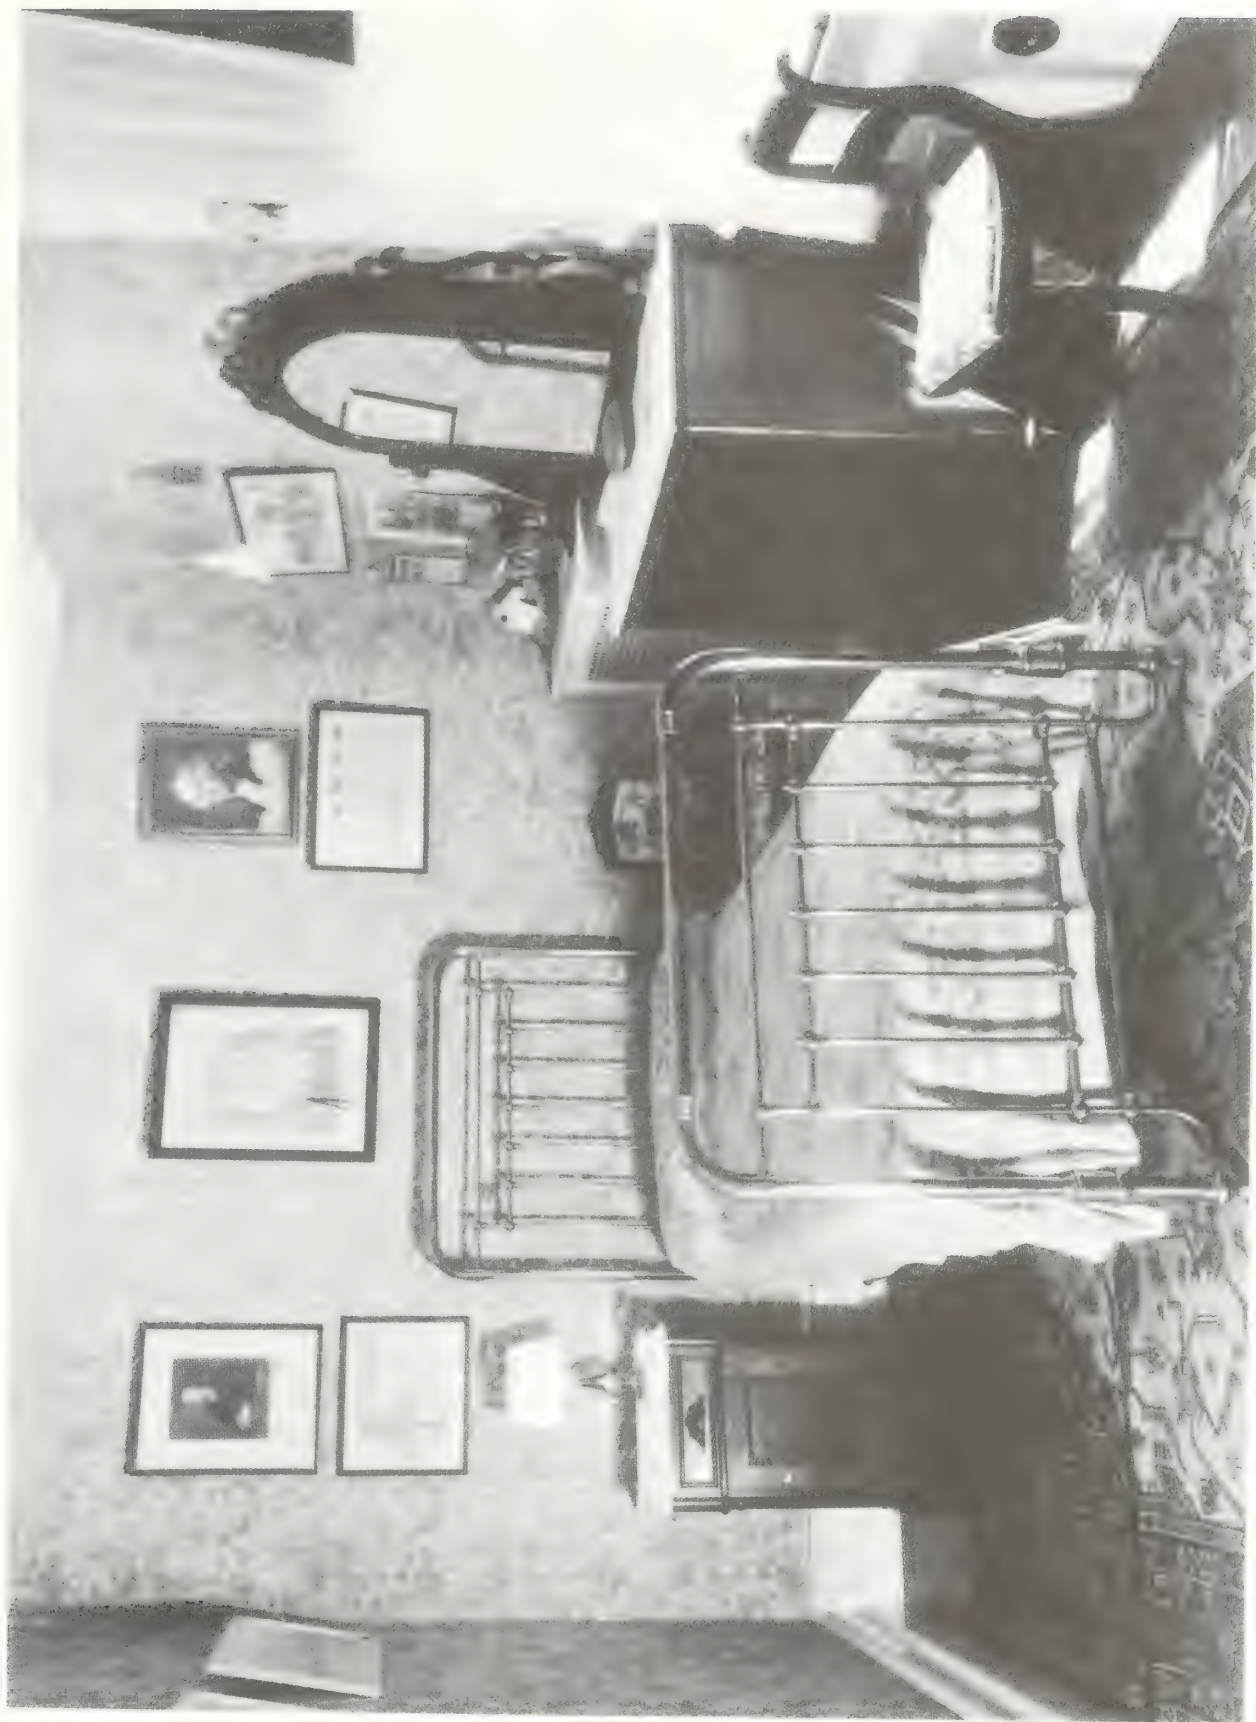
Figure 71. Home of FDR: FDR's Boyhood Room, looking north, 1941.

This room (fig. 71) is the original (ca.-1800) northeast bedroom in the main house. It has a south-wall closet that was formerly part of the East Bath (Room 211).

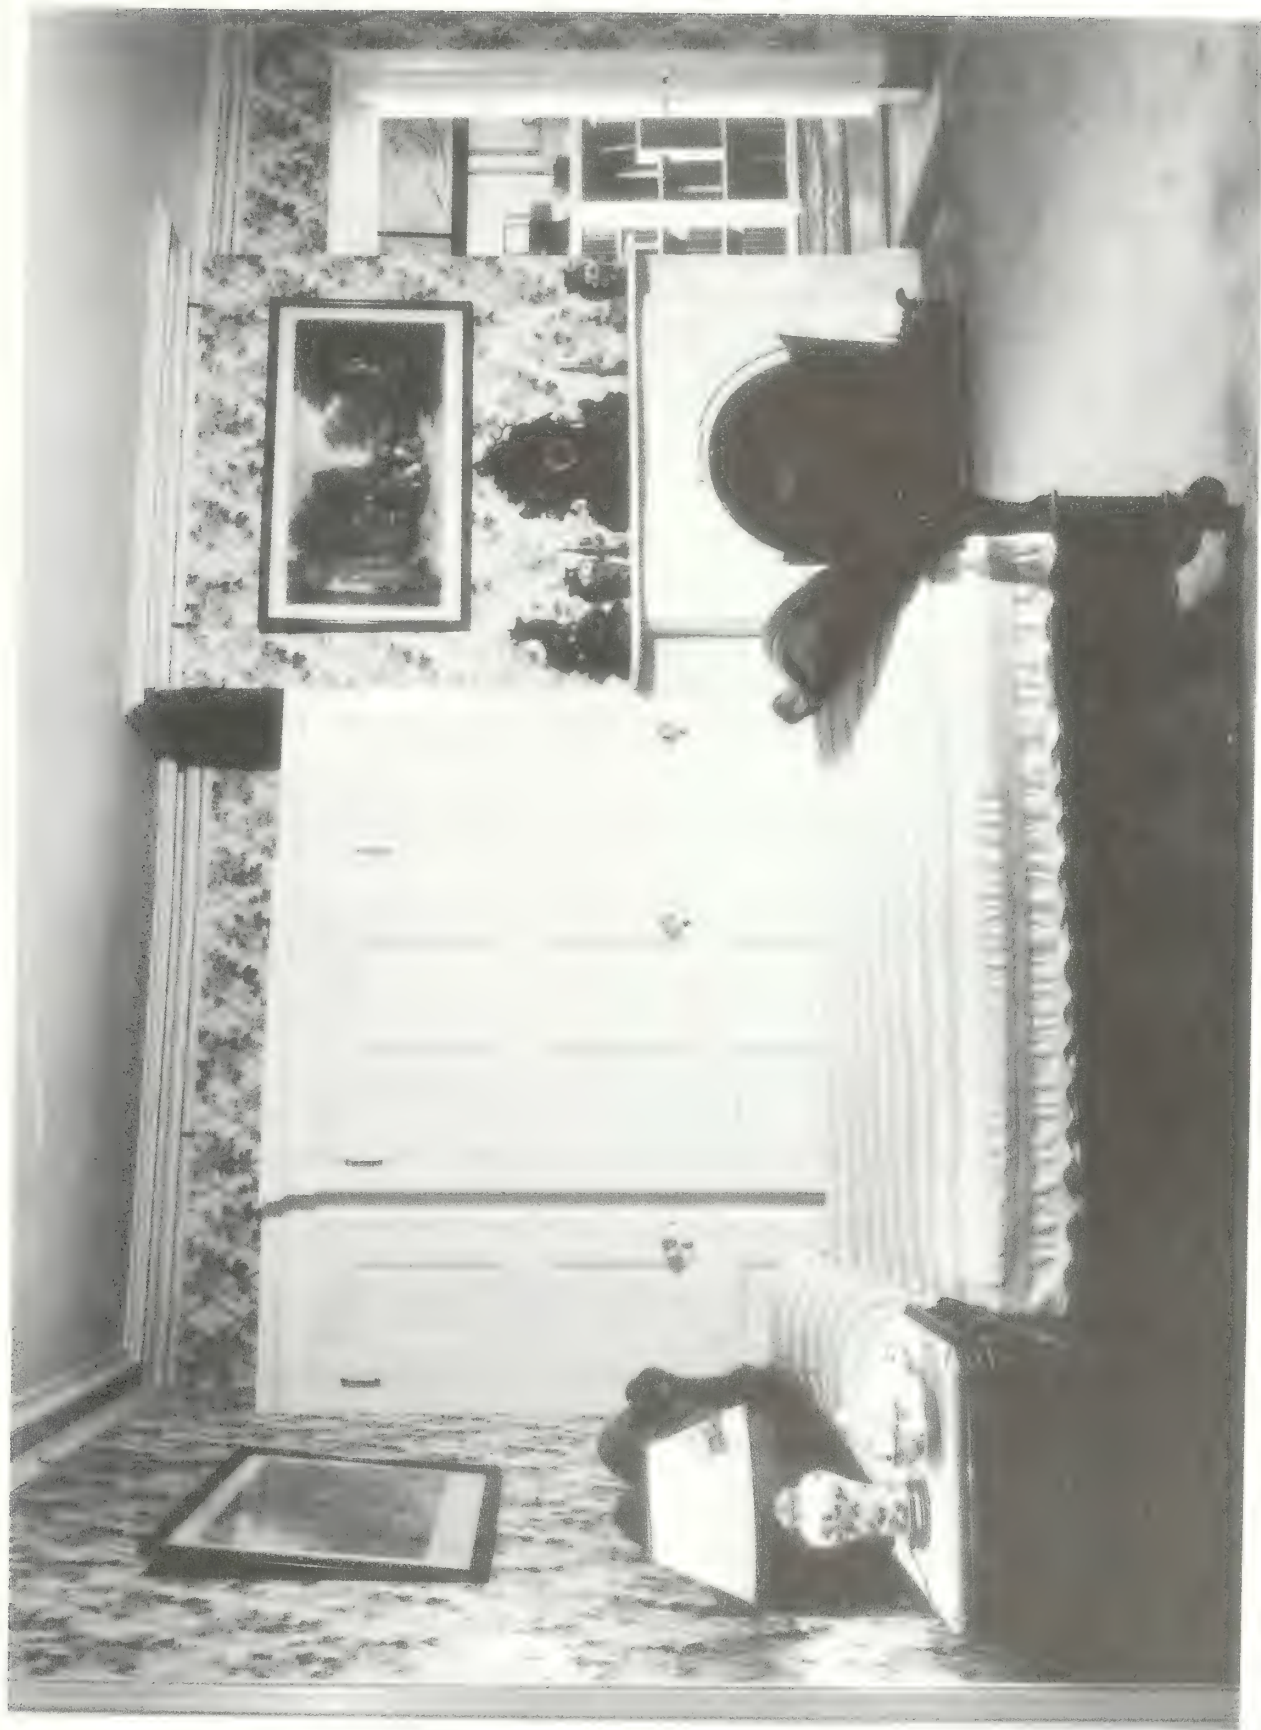
Figure 72. Home of FDR: Pink Room, looking east, 1941.

This room (fig. 72) is the original (ca.-1800) northwest bedroom in the main house. It has a fireplace and three closets on its east wall, as well as a west-wall closet.

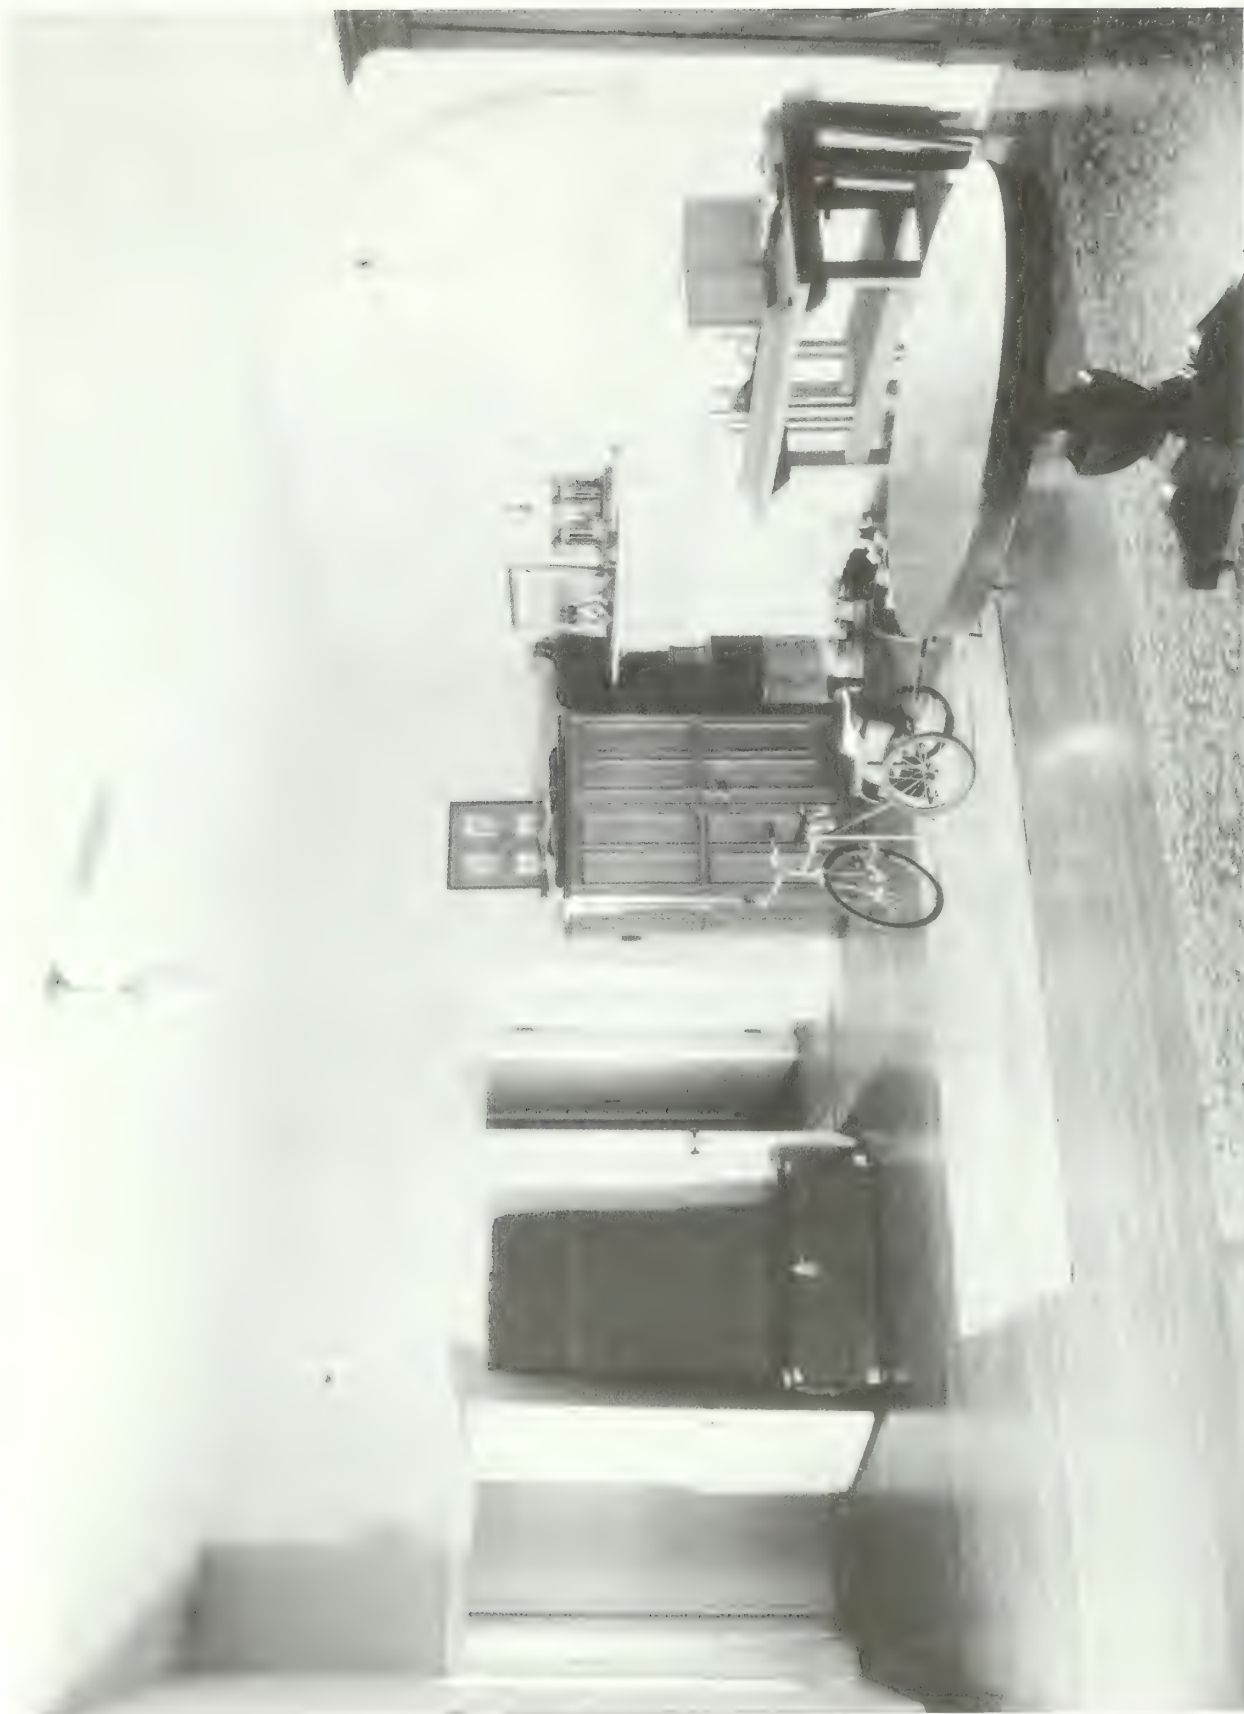
Figure 73. Home of FDR: Playroom, looking northeast, 1941.

This room (fig. 73) is in the original (ca.-1800) main house, but its present appearance dates to the 1915 remodeling. The room is mostly rectangular in shape, with three exceptions. A large closet occupies the southeast side of the room; an alcove is centered in the west wall, and the northeast corner of the room jogs in slightly to make space for the East Bathroom (Room 312).

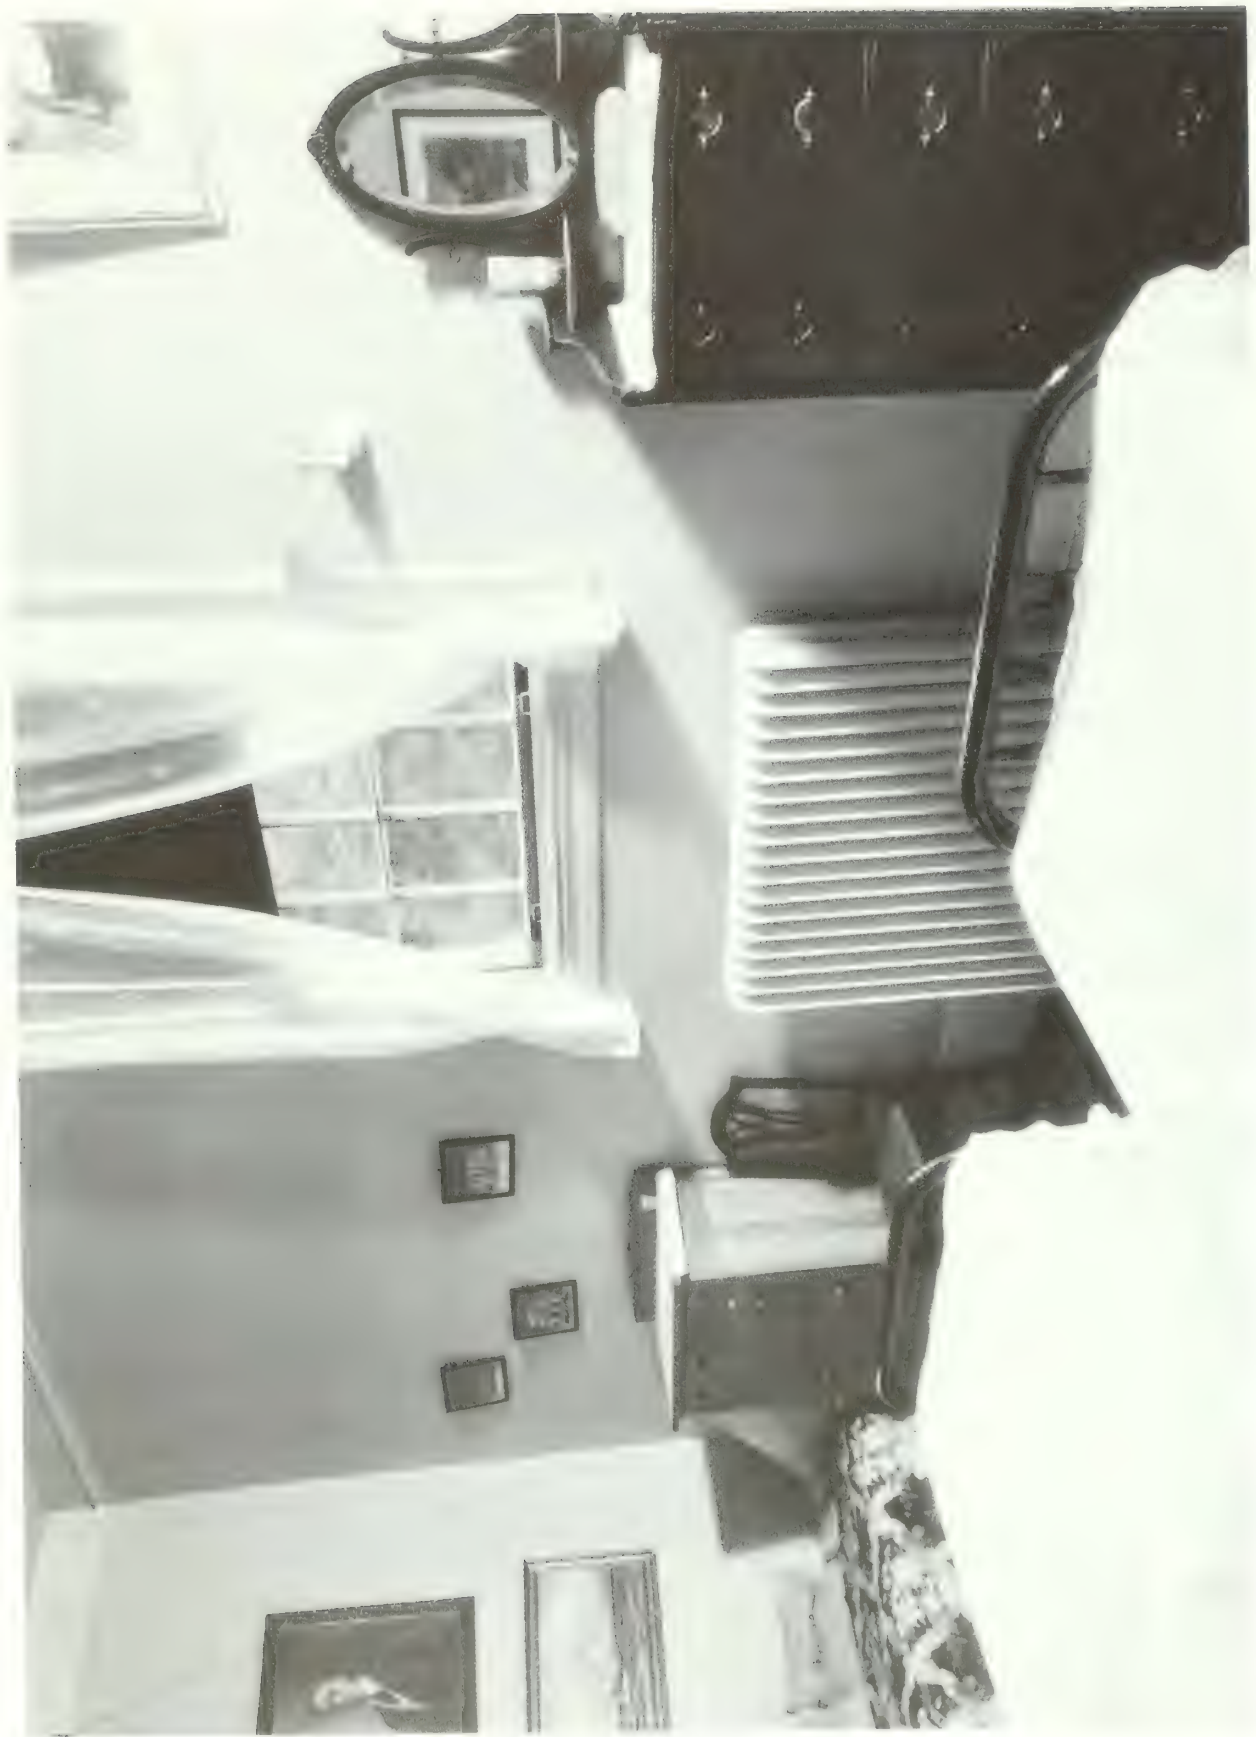
Figure 76. Home of FDR: Chamber #13, looking northeast, 1941.

This room (fig. 76) was also created in 1915 as part of the north tower over the service wing. Its west end was built on top of the original kitchen wing, along with the adjacent elevator shaft and the north end of the Hall (Room 311). Its middle section was constructed on top of the ca.-1892 and 1900 additions to the kitchen wing. Its east side was built on top of 1915 construction that was added to the front of the service wing, to create a projecting effect for the new tower. Unlike the service rooms at the rear of the tower, this bedroom's floor level is even with the third floor of the main house. This may have been done deliberately, since the room was part of the family's quarters. This room has a large closet in the west wall. Between this closet and the north wall of the house is a light well that illuminates the second-story Trunk Room. It is possible that this light well is the shaft for the first elevator.
